MEMORANDUM

SUBJECT: Site Assessment: Certain-Teed Transite Pipe
A.K.A Maline Creek, 600 St. Cyr Road, St. Louis, Missouri
TDD#: T07-9203-012
PAN#: EM00307SAA
EPA/OSC: Mark Roberts

Photographic Record

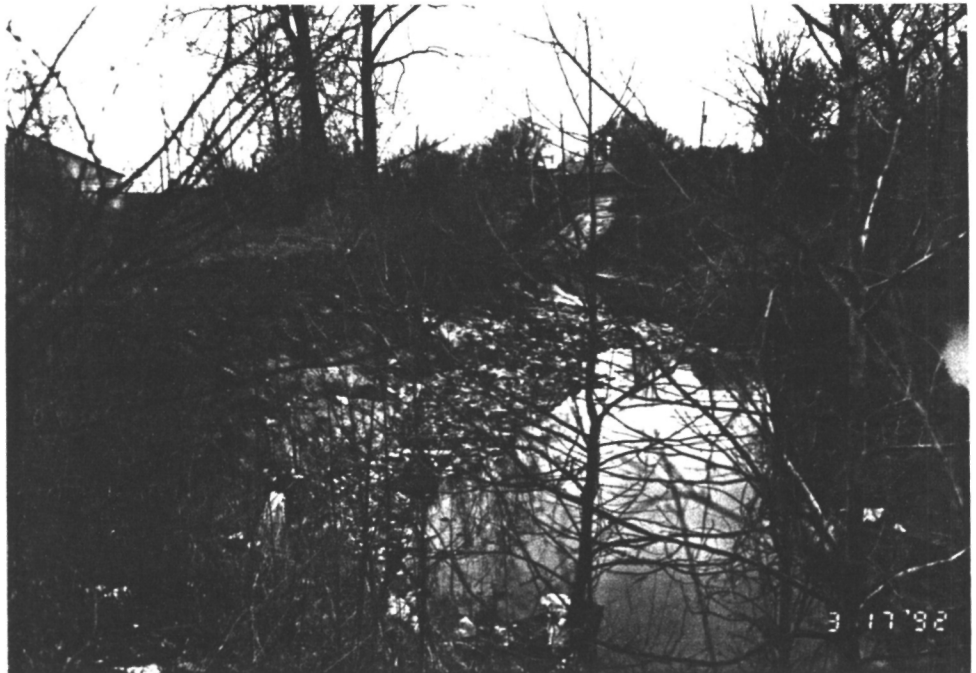
Photographer: Joe Parish
Date/Time : 3/17/92/1215
Lens: Type: 50mm/normal
Serial No.: 1063023
Frame No. : 1
Direction : E
Comments :
South of former GAF, north
bank of creek

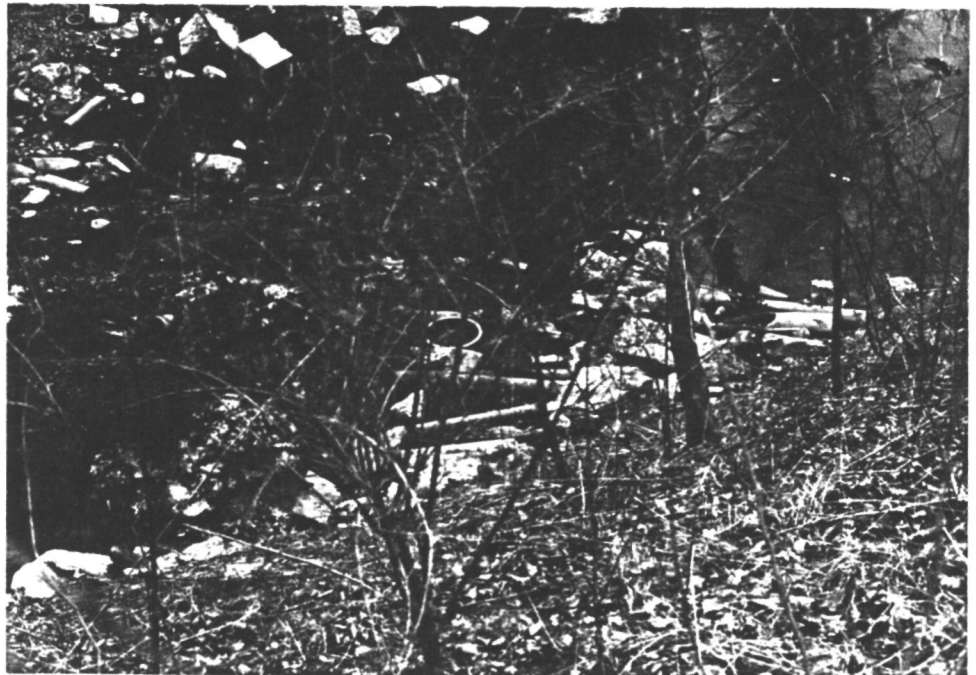
Photographer: Joe Parish
Date/Time : 3/17/92/1217
Lens: Type: 50mm/normal
Serial No.: 1063023
Frame No. : 2
Direction : S
Comments :
North edge of creek, SW of
Certain-Teed

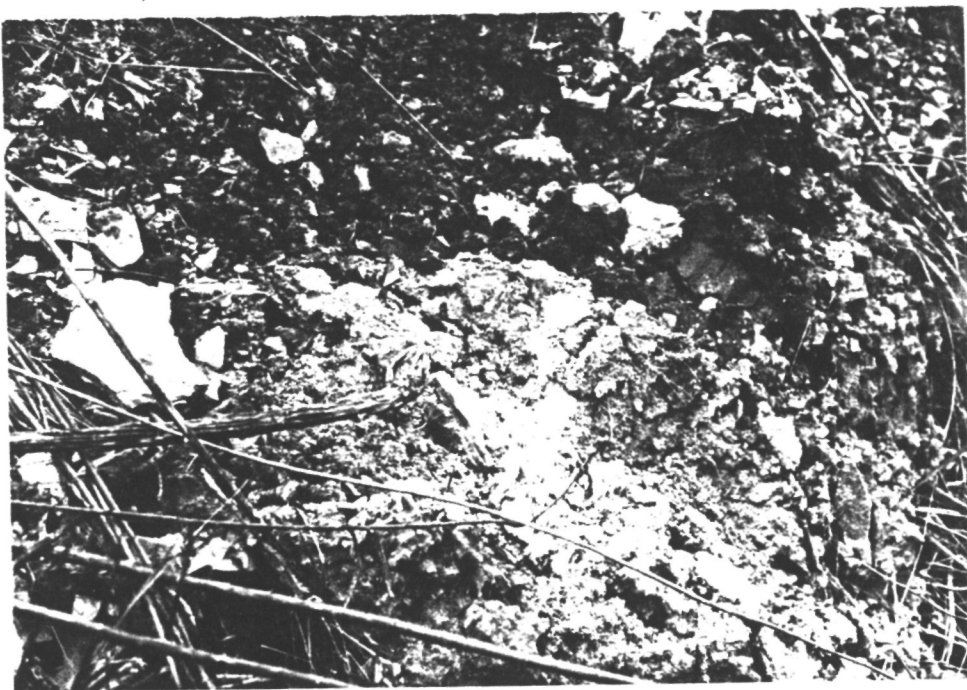
to be sheeting was visible in the rip-rap area. What appeared to be insulation material had been exposed by erosion at the upper bank of the creek. Both this material and the sheeting were sampled (sample numbers 005 and 006, see the site map for location). The insulation material was friable and particles became airborne during sample collection. The sheeting appeared hard, stable, non-friable, and was sparsely scattered throughout the rip-rap.

Photographer: Joe Parish
Date/Time : 3/17/92/1220
Lens: Type: 50mm/normal
Serial No.: 1063023
Frame No. : 3
Direction : SE
Comments :
North bank, apparent
insulation, sample 5 location

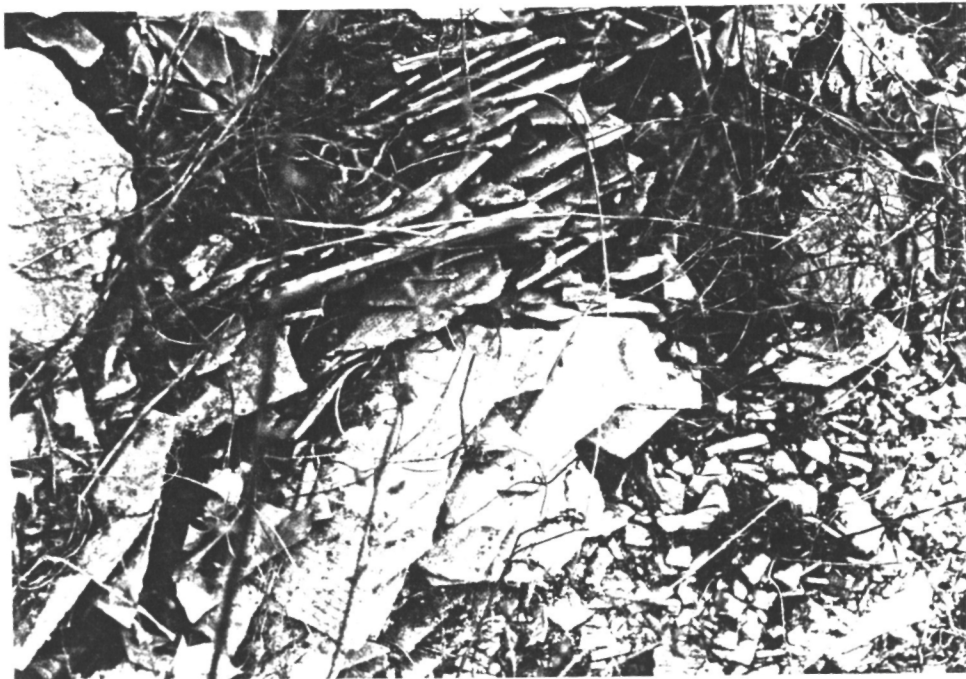
Photographer: Joe Parish
Date/Time : 3/17/92/1230
Lens: Type: 50mm/normal
Serial No.: 1063023
Frame No. : 4
Direction : SE
Comments :
North bank, sample 6 location

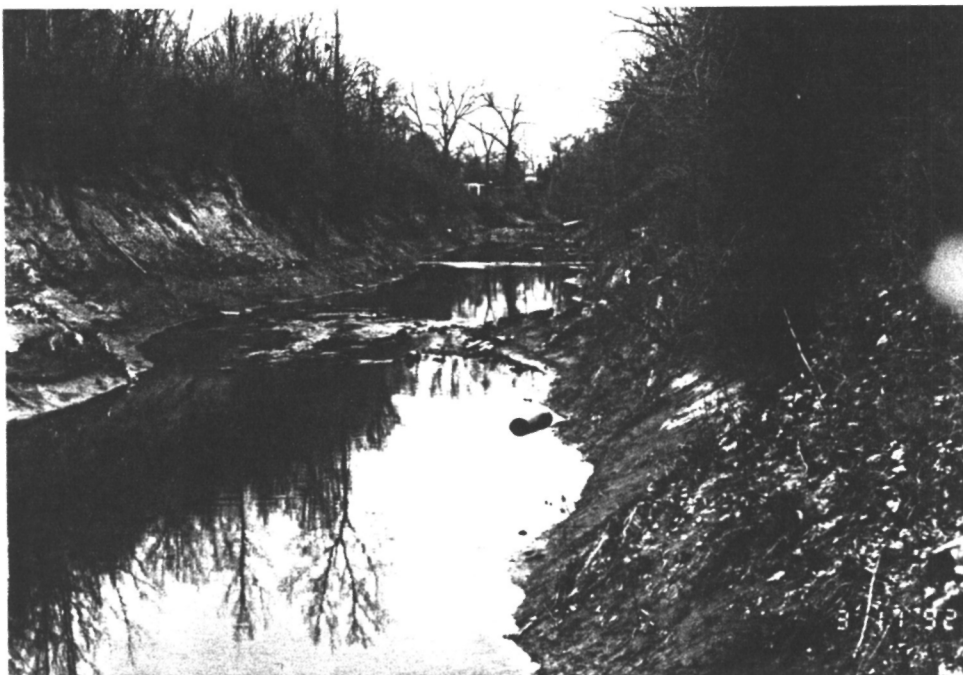
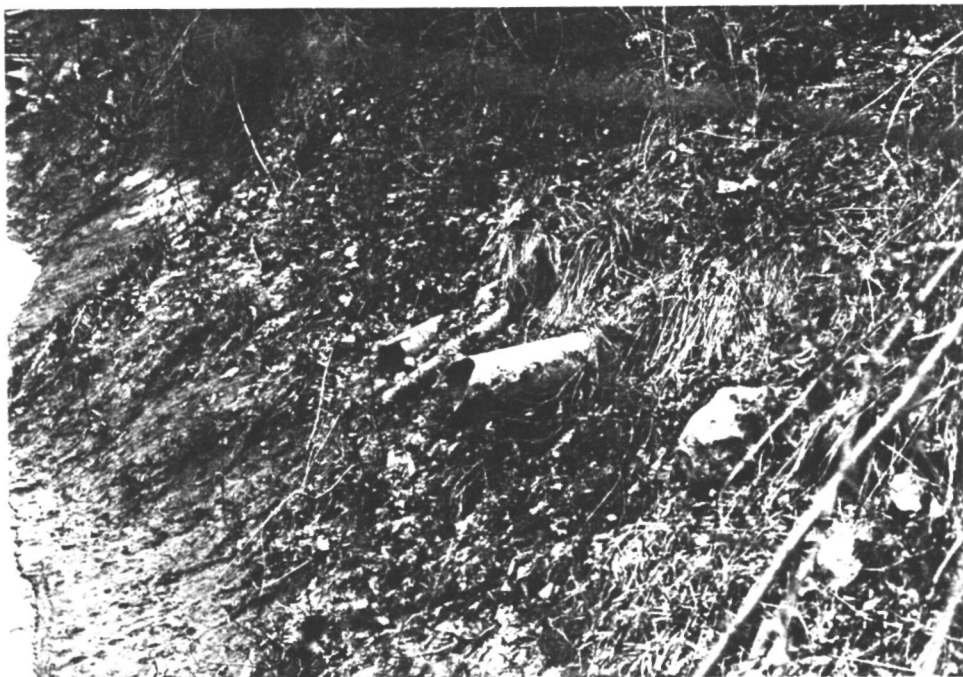
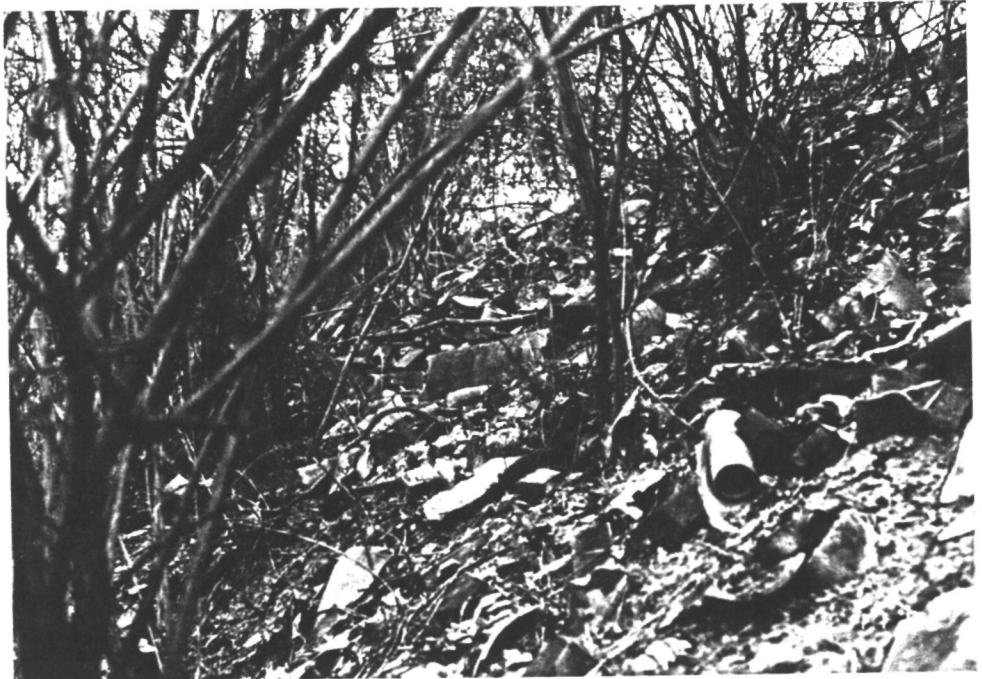
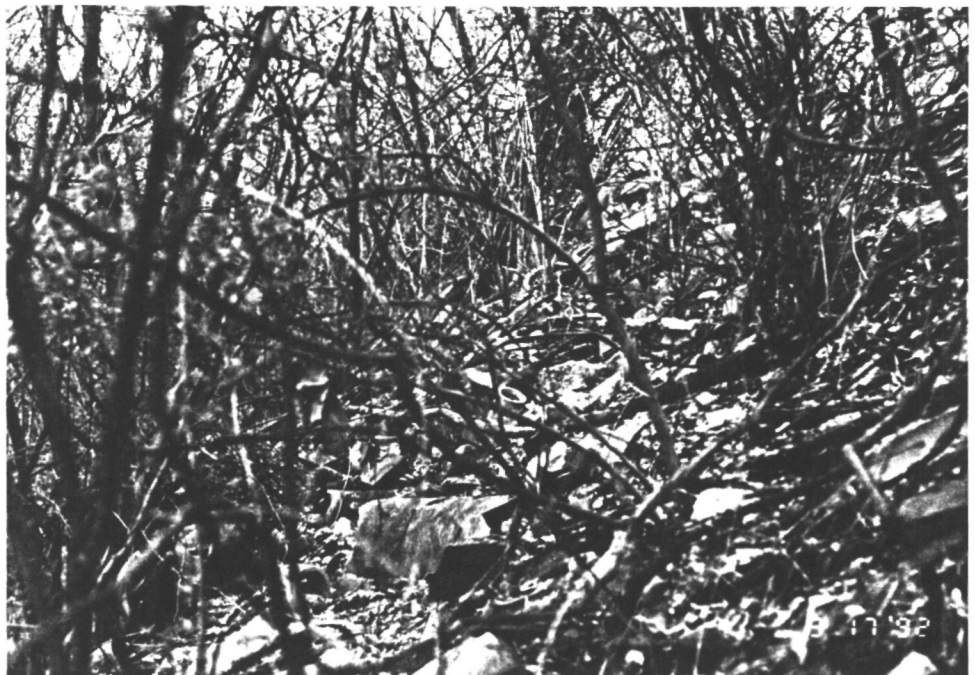
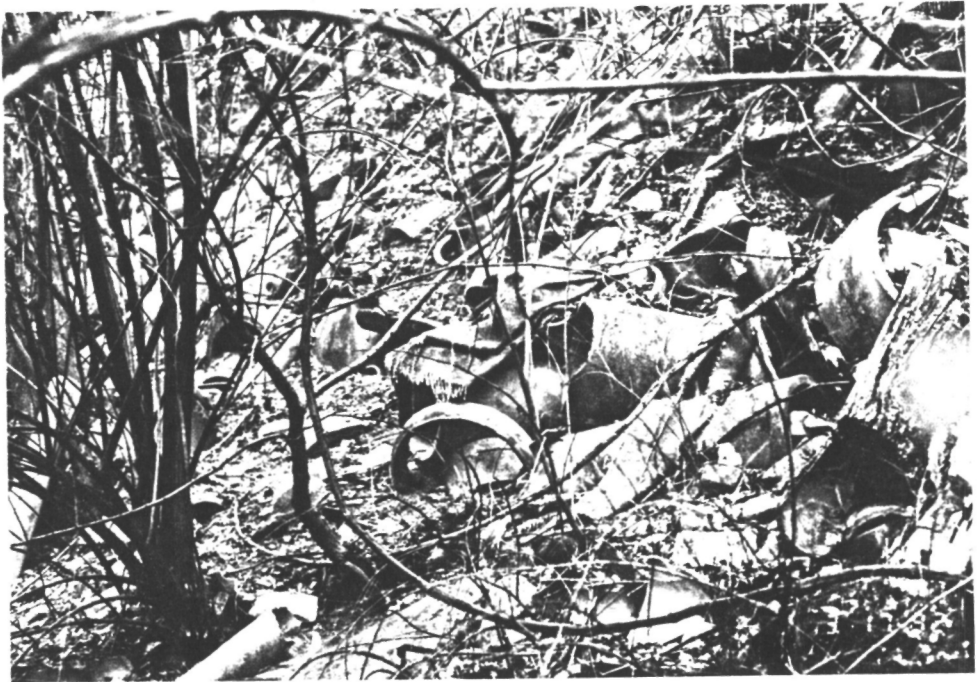
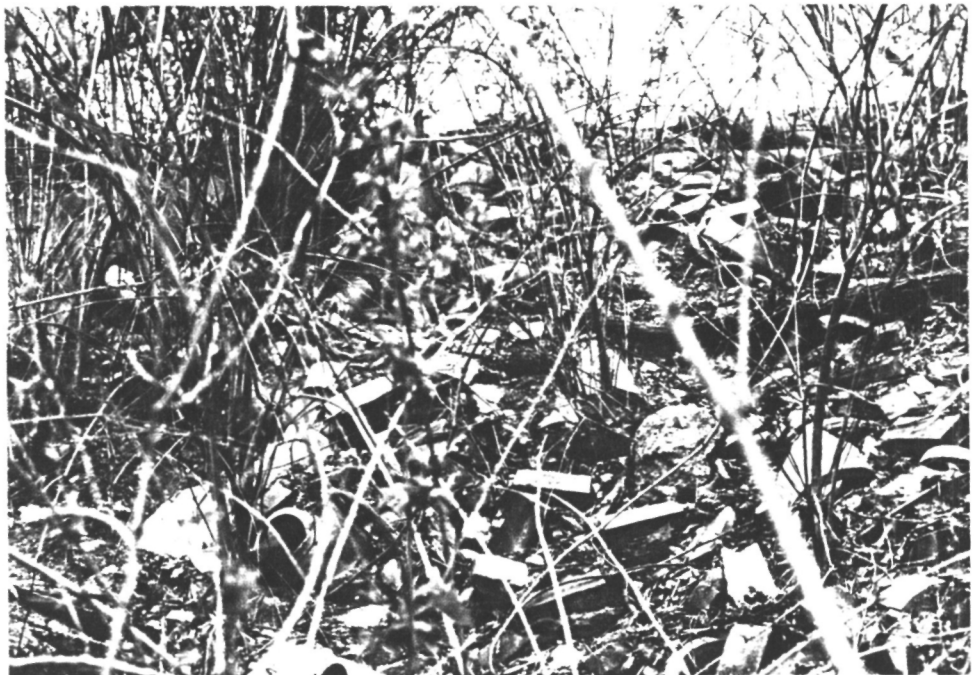
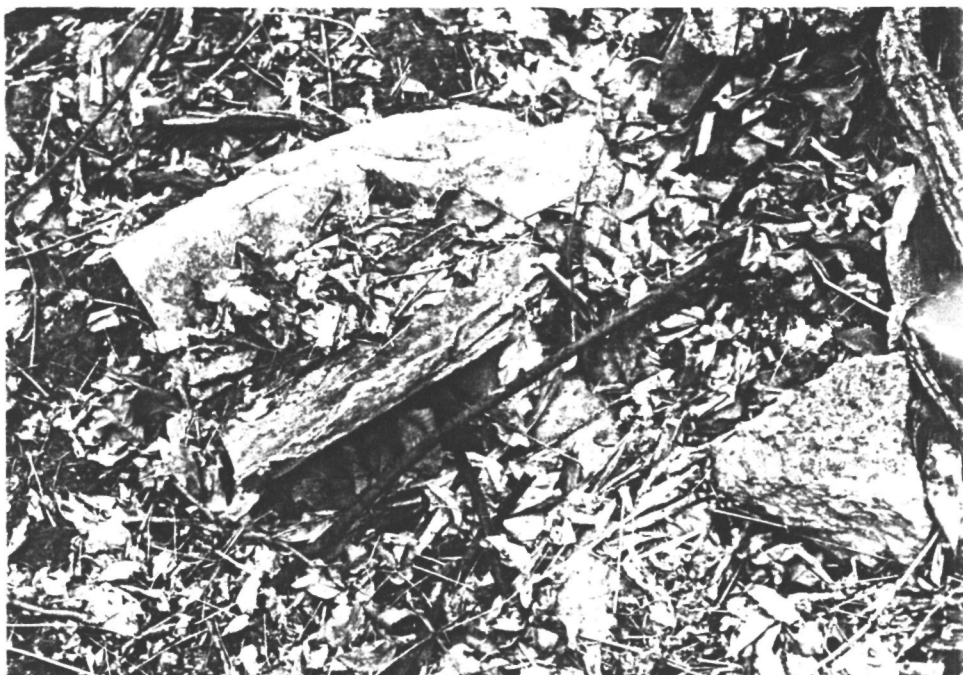
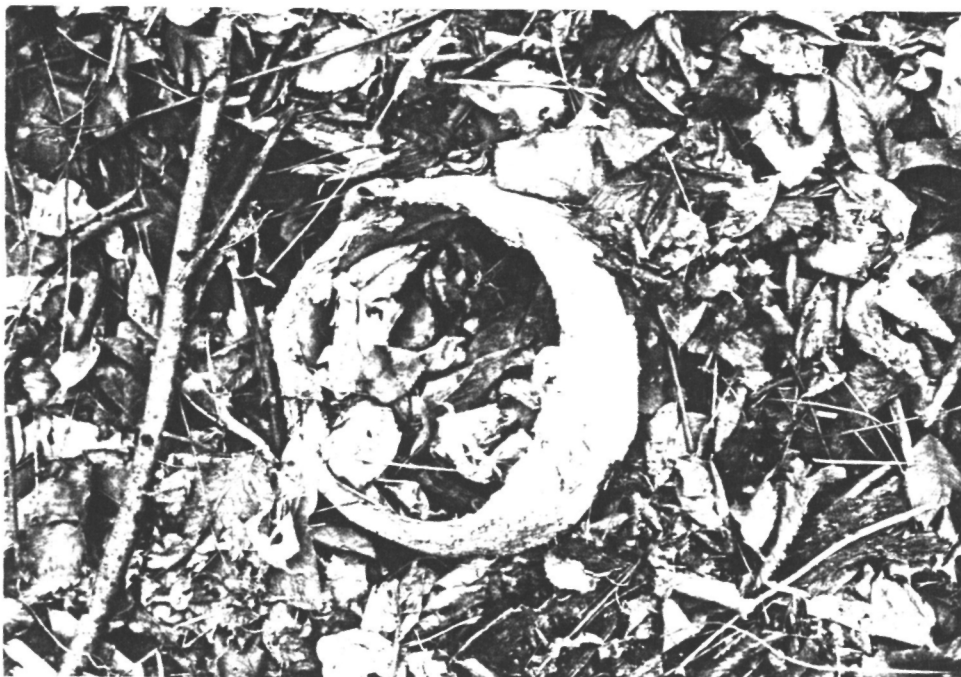
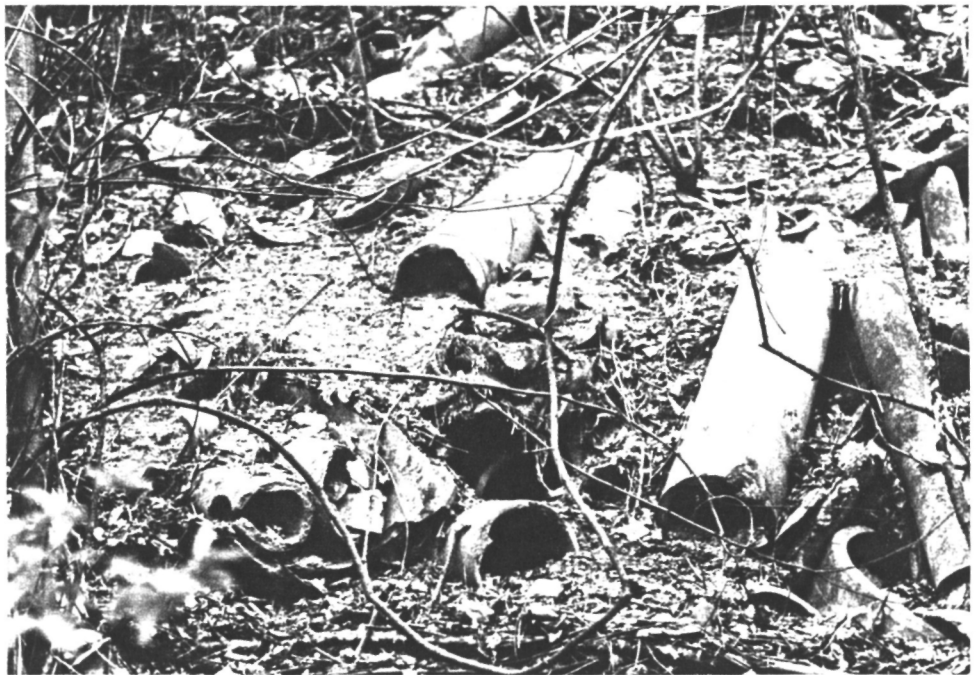
Next, TAT walked along the upper and lower banks of Maline Creek. TAT observed large quantities of transite pipe scrap material scattered down to the creek bed and extending downstream to approximately the neighboring property boundary. The upper bank of the creek appeared to be eroding, exposing more transite pipe scrap. The scrap material appeared to derive from a berm built up along the edge of the upper creek bank, presumably to cover the transite scrap. Sample number 003 was taken at this location (see site map). Transite pipe was scattered on both the near and far banks of the creek, as well as in the creek bed. A composite sample (number 004) was collected from material at these locations. The transite scrap appeared to be in two forms - scrap of the pipe itself, and scrap of the ring connectors that joined the pipe sections. The connectors were slightly friable. The pipe scrap was very hard and could only be broken by using a sledge hammer. In either case, fibers were observed sticking out of the weathered broken edges of pipe scrap.

Photographer: Dave Kinroth
Date/Time : 3/17/92/1240
Lens: Type: 50mm/normal
Serial No.: 1063023
Frame No. : 5
Direction : NW
Comments :
Transite pipe and connectors,
north creek bank south of
former Certain-Teed
